METALLURGICAL AND SURFACE DAMAGE ANALYSIS IN A COPPER MOLD AFTER SERVICE

34th Danubia-Adria Symposium on Advances in Experimental Mechanics
University of Trieste, Italy, 2017

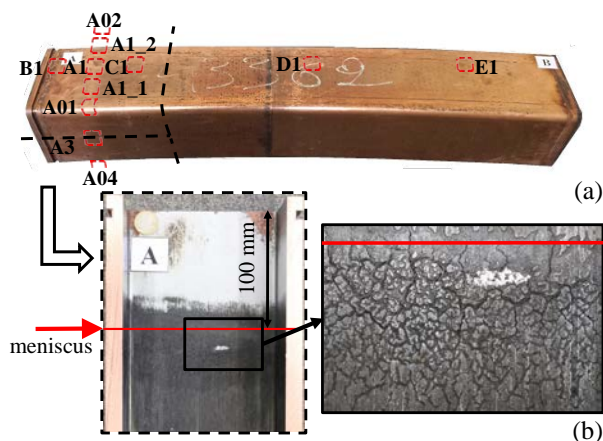
Fig. 1. Mold under investigation with positions of specimens (a), damaged inner surface area (b).

The visual inspection has evidenced that the mold is heavily damaged in the meniscus area, as indicated in Fig. 1b. Close examination of the mold inner surface shows that a web of cracks is formed approximately 130 mm from the mold top, i.e. in the level where the surface of the mold reaches the maximum temperature.

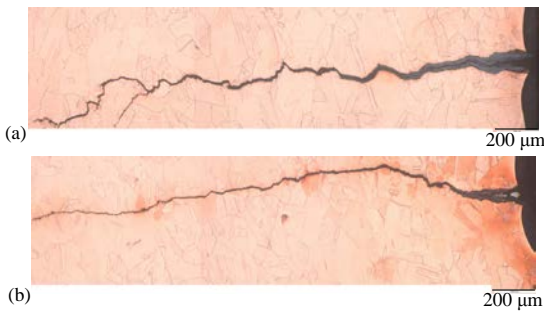
The microstructural examination of the samples, extracted in the area of meniscus, has evidenced the presence of many cracks, mainly in the samples A1, A1_1, A1_2, A3, and A4. These samples are situated in the most stressed region of the mold. Fig. 2a and 2b (samples A3 and A1_2

respectively) show that cracks initiate at the surface and then propagate through the mold walls. The cracks seem to be transgranular and are contoured of some blue deposits, which will be further investigated by means of SEM+EDXS. It is observed that the crack nucleation region lacks the original chromium protective coating that probably has been detached by the degradation process.

Fig. 2. Cracks on specimen A3 (a), and A1_2 (b).

Metallurgical analysis proved the transgranular characteristics of the cracks, thus suggesting that thermal fatigue is the main cause of failure, as suggested in [2].

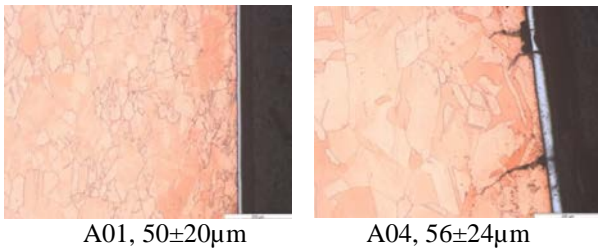
Fig. 3. Microstructure of samples taken at corners.

Considering samples from corners, only few small cracks are found on one side (e.g. A04), while no

visible cracks are observed on the opposite side (e.g. A01), see Fig. 3. Some samples present a detachment of the coating, caused by the wear of the mold. The samples B1 and C1 do not have both visible cracks and the chromium coating layer, which presents a thickness of approximately $100 \mu\text{m}$ (Fig. 4). Indeed, these samples have been extracted outside the meniscus area, where probably the thermal stresses are lower. The SEM analyses performed on specimen A1, have evidenced the presence of Pb, Zn and S, see Fig. 5. These elements probably are present in the molten steel as residuals and they have been infiltrated because of the high chemical affinity with Cu. It is possible that these elements, reacting with the Cu, have produced a brittle phase, which has promoted the crack nucleation and propagation.

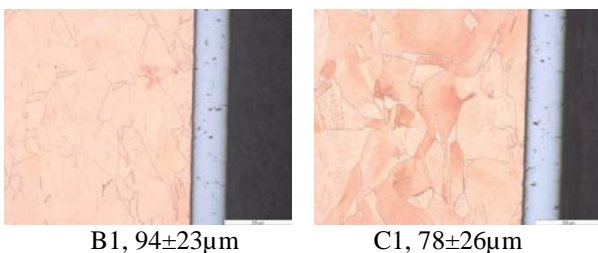
Fig. 4. Microstructure of B1 and C1 samples.
