NUMERICAL AND EXPERIMENTAL IDENTIFICATION OF CRACK IN THE STACKER CONSTRUCTION

Fig. 1. Stacker A2RsB 15400

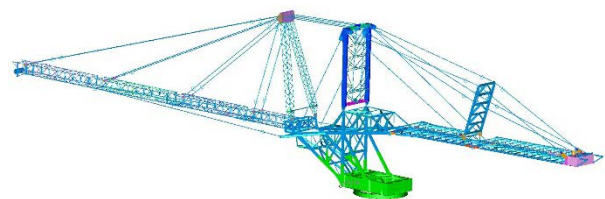
Fig. 2. The numerical model of the stacker

The numerical model uses discretization using beam and shell finite elements. The bar structures of the discharge boom, the counterweight boom and the masts were modeled using beam finite elements, the support structure, the tower were modeled with shell elements. Numeric calculations were performed for load cases defined in DIN 22261 [5]. Particularly important in these calculations are the cases to determine the fatigue strength used in the proof of service life. The results from these calculations show the places susceptible to fatigue cracks. Figure 3 shows stress of the structure with a high level of stress difference, in which serious fracture has been identified. This is a particularly important place, as all machine assemblies are connected to this carrier system. The failure of one of the beams of this carrying system could have resulted in a catastrophe of the whole machine.

One of the basic tasks in determining the condition of machines after long-term use is to determine the places of high stress [3, 4]. For this purpose, the finite element method was used. The numerical model of the stacker carrier structure is shown in Fig. 2.

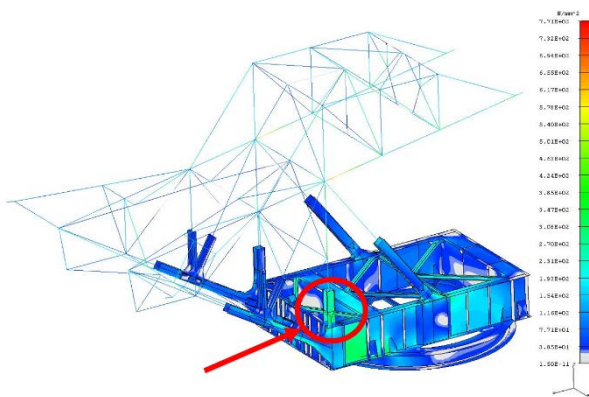
Fig. 3. Stress for load case H1b [5] with marked place of crack

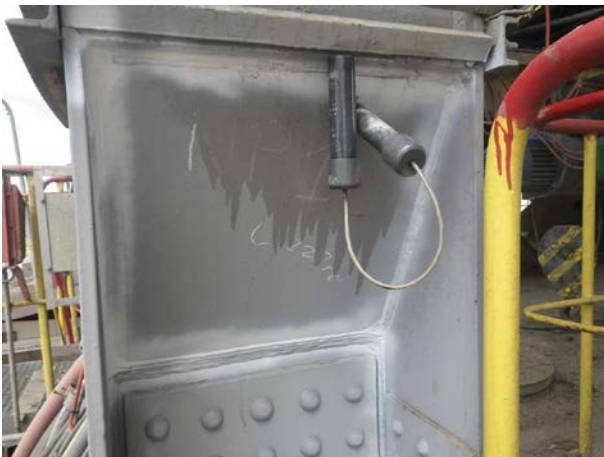
Fig. 4. Cracking at the weld in the tower supporting structure

A crack of about 20 cm in length was found at the weld at the change of box cross section to I-beam. Upon detection of this cracks, the machine has been stopped to repair the damage.
